Scheme: **A65 Long Preston Bridge**
Problem: **Degradation of concrete retaining/parapet walls**
Solution: **Concrete patch repairs and replacement of concrete coping**
Client: **North Yorkshire County Council**

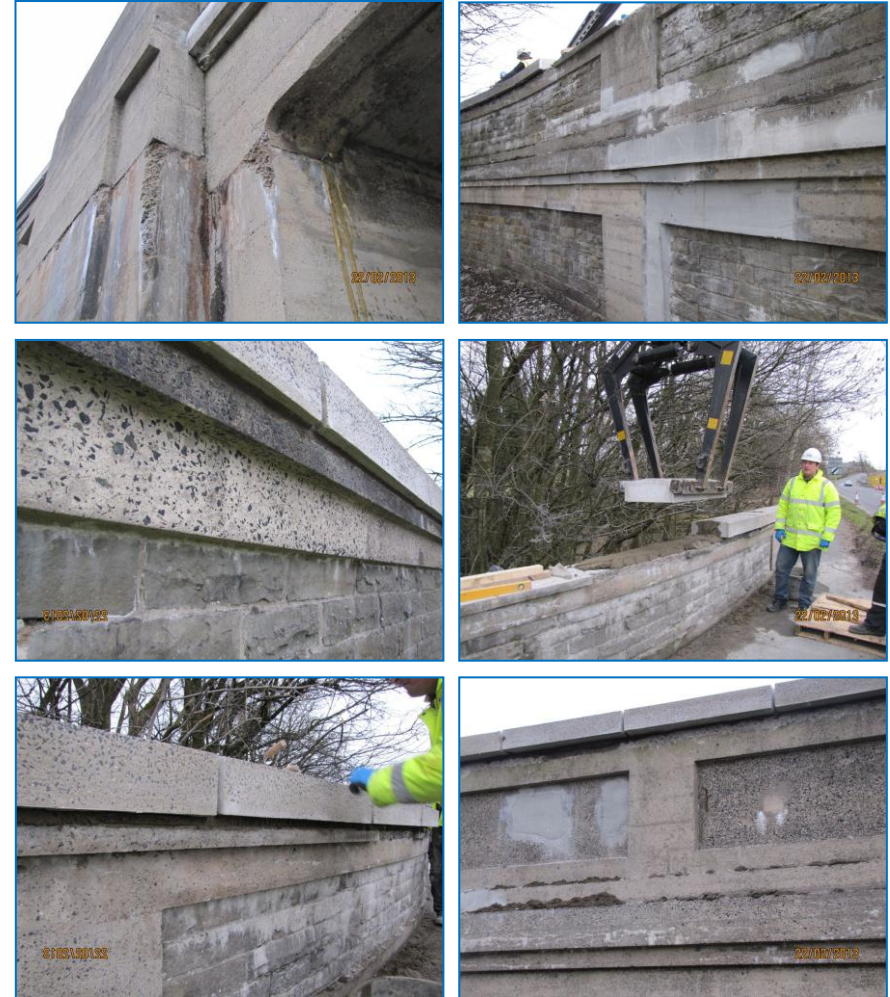
Corrosion of reinforcement and more crucially degradation by frost affecting the concrete retaining and parapet walls led to a scheme of refurbishment awarded to Ram Services Limited by term contractor Ringway.

All localised areas of cracking and spalling due to rebar corrosion were cut out, prepared and reinstated with cementitious repair mortar.

The existing insitu concrete coping detail was considered to be beyond repair, and was cut from the wall completely using diamond sawing techniques, lifted clear and removed off site.

A specially cast, sectional coping was then constructed, hoisted into position, bedded in place, and secured with resin bonded steel dowels.
