Scheme: **Grand Union Canal Rowington Embankment**

Problem: **Seepage of canal water through original precast concrete piled wall lining**

Solution: **Injection of aquareactive polyurethane resin grout**

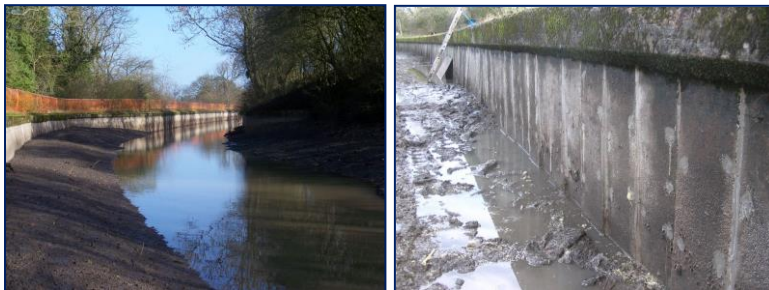
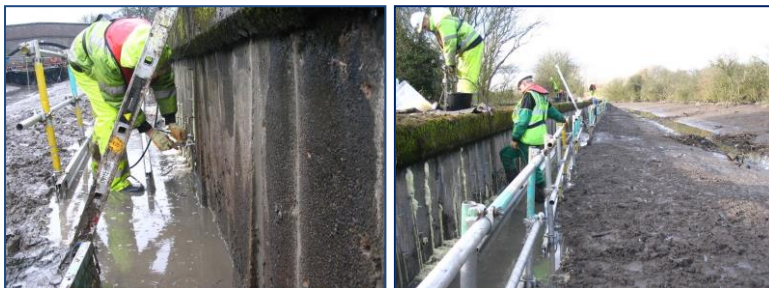
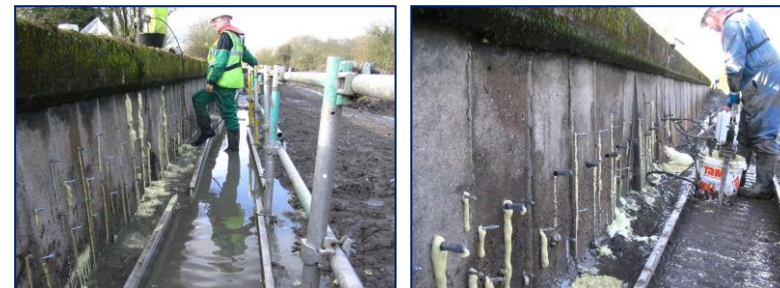
Gaps between precast concrete piles lining the canal were found to be allowing voids to form behind the piles, allowing water to exploit weaknesses in the canal bank and create flow paths through the bank to lower levels beyond.

Ram services devised a method to seal the gaps between the piles with hydraulic cement, and then to fill the voids behind with expanding chemical grout, thereby sealing the leak paths into the towpath bank and beyond.

Work was undertaken during a planned de-watering of the canal, using a range of lightweight and easily portable equipment.
