Scheme: **Walton le Dale WwTW – Humus Tank Wall Upgrade**

Problem: **Break up of concrete wall and disruption to scraper bridge operation**

Solution: **Replacement of top of wall using precast concrete coping units**

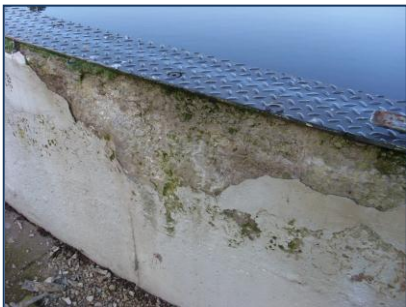
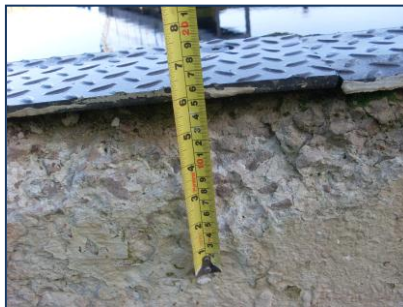
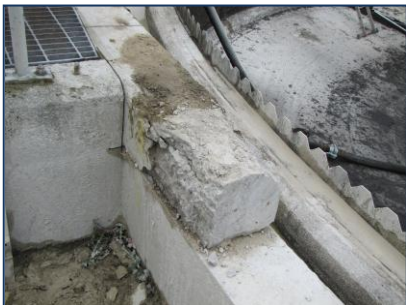
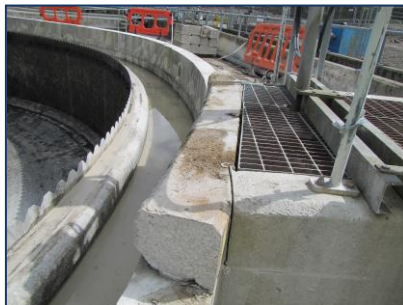
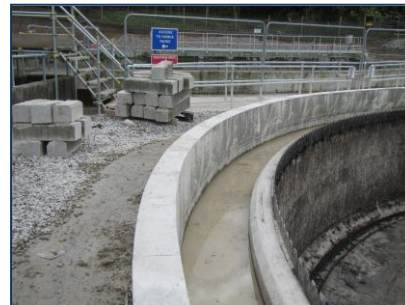
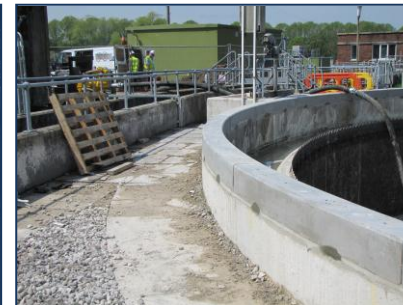
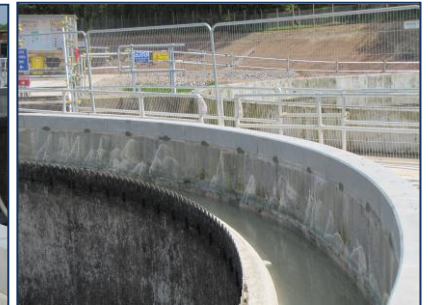
Following long term difficulties with scraper bridge operation being disrupted by degradation of concrete forming the outer tank wall, and a solution involving mechanically fixed steel plates not having provided a long term fix, Ram Services Limited developed a solution to permanently repair the tank walls and maintain the operation of the scraper bridge.

Ram Services' site team dismantled the unsuccessful steel plates, and then rapidly removed the degraded top section of the wall using diamond wall sawing techniques. The concrete was taken down to a predetermined level in sections, stacked, and then lifted clear of the structure. The wall was then reinstated to its original section using specially manufactured precast concrete coping blocks, laid on high strength repair mortar and secured with resin grouted dowel bars.

Sections of the wall which could not be replaced were repaired with a highly durable resin based repair mortar.
