Scheme: **Hazel Grove WwTW**

Problem: **Long term deterioration concrete aerator bridge structures**

Solution: **Condition investigation, Concrete repairs, Surface coatings and Deck Waterproofing**

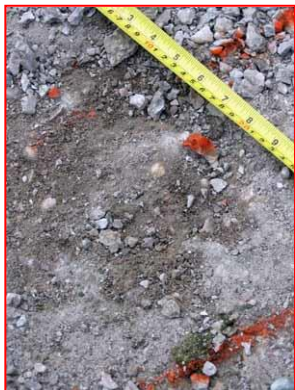
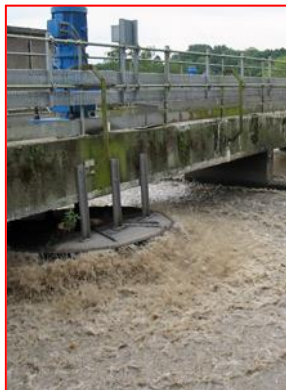
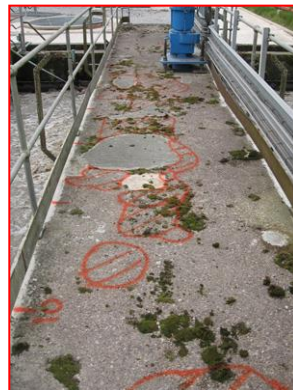
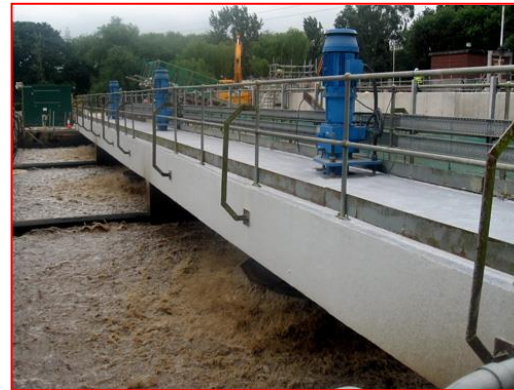
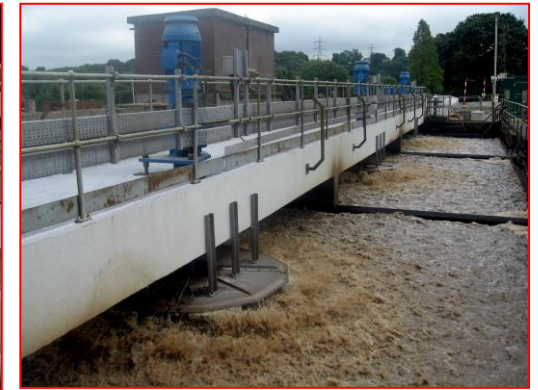
Defects included large areas of crumbing concrete on the deck surface of the bridges, poorly compacted concrete along the beam arrisses, and areas of cracking of the concrete where reinforcement corrosion had set in as a result of poor cover. During two aeration lane outages, scaffold platforms beneath each bridge span were constructed, and all exposed concrete surfaces cleaned off using high pressure water jetting techniques.

Defective areas of concrete were marked out, and a series of repairs using polymer modified cementitious repair mortar undertaken. Areas of poor compaction were cut back and made good with cementitious fairing mortar. On completion of the repairs, the bridge decks were waterproofed with a polyurethane finish normally applied to multi-storey car parks, and the sides and soffits finished with an anti-carbonation coating system.
