Scheme: **Liverpool WwTW BAFF Cell Plant**

Problem: **Suspected structural damage to reinforced concrete BAFF cell floor slab**

Solution: **Structure condition surveys and removal of defective floor slab**

Client: **United Utilities Water** Main contractor: **Birse Water**

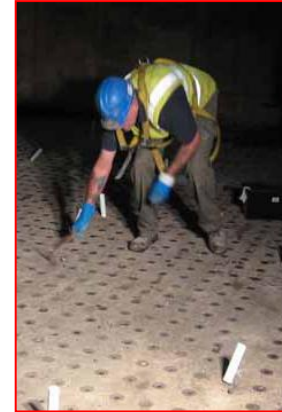
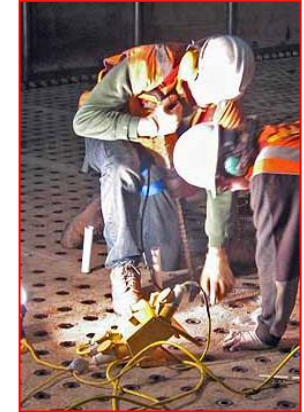
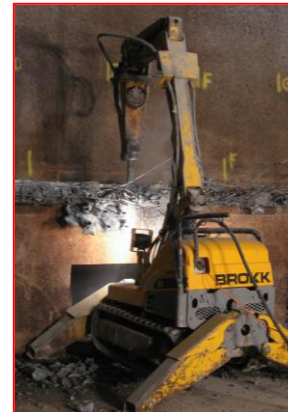
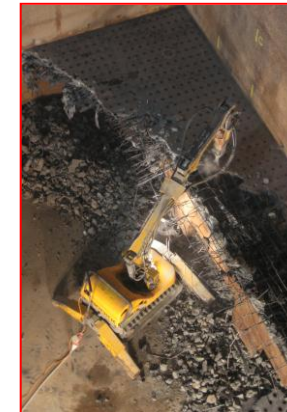
The condition of one cell floor was considered such that replacement was necessary, and Ram Services Limited diamond division was brought in to demolish and remove the floor prior to re-construction by others. Limited access and the need to maintain adjacent BAFF cells in service called for the use of a robotic demolition unit to break up the floor slab into small fragments, whilst keeping vibration levels to a minimum.

All debris was then removed via existing 600mm diameter manways on electrically powered conveyor belts.
