Scheme: **A39 Chewton Mendip Retaining Wall**
Problem: **Long term deterioration of masonry retaining wall alongside major route**
Solution: **Reconstruction, re-pointing and grouting of masonry**
Client: **Somerset County Council** Main contractor: **Atkins Highways**

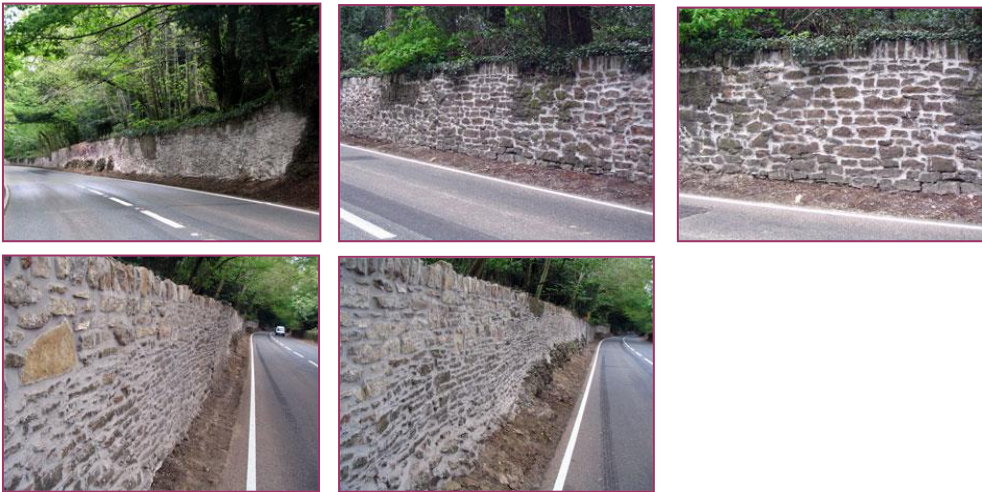
Work undertaken by the Ram team included localised re-construction of defective sections of retaining wall, extensive pressure pointing and grouting of the worst voided areas of the wall.

The original construction and condition of the wall, coupled with resulting heritage considerations, dictated use of selected lime based repair compounds, and matching techniques for preparation of masonry and application of new material. These included use of hand tools and low pressure water jetting to prepare existing wall surfaces, and pre-packaged, colour matched Easipoint Heritage Mortar, placed using pressure pointing equipment to re-point the wall joints. Highly flowable, low strength lime based grout placed under low pressure was used to infill significantly voided sections in the retaining wall.
