CASE HISTORIES

Scheme: LIVERPOOL DOCK

Problem: STRENGTHENING QUAY WALL

Solution: **DIAMOND FLOOR SAWING AND DIAMOND DRILLING**

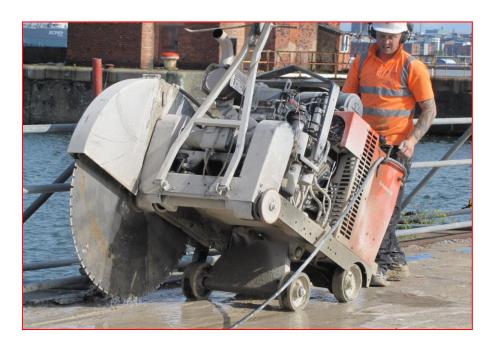
I H Brown contacted Ram Services with a problem of how to separate the sea wall from the quayside to enable the section to be broken out without causing any vibration.

Ram Services suggested utilising a floor saw which is capable of cutting 700mm deep, which was the depth of the quayside slab.

The floor saw being used has a John Deere engine which produces 80hp at the blade shaft and can be fitted with a 1500mm blade.

Sections of the quayside were in excess of 800mm deep, in these areas Ram Services utilised a hydraulic track saw which could be fitted with a 2000mm blade.

The aggregate in concrete being saw cut was varied, there was limestone, quartz and riverbed gravel.

Ram Services also utilised two smaller floor saws to cut over 2000 linear metres varying from 150mm to 300mm deep, we also diamond drilled in excess of 500 number 45mm diameter cores 300mm deep.
