**Scheme:** Yeoman Hey IR  
**Problem:** Ground Water Ingress into Draw off Tunnel and Shaft  
**Solution:** Injection Leak Sealing  
**Client:** United Utilities Water

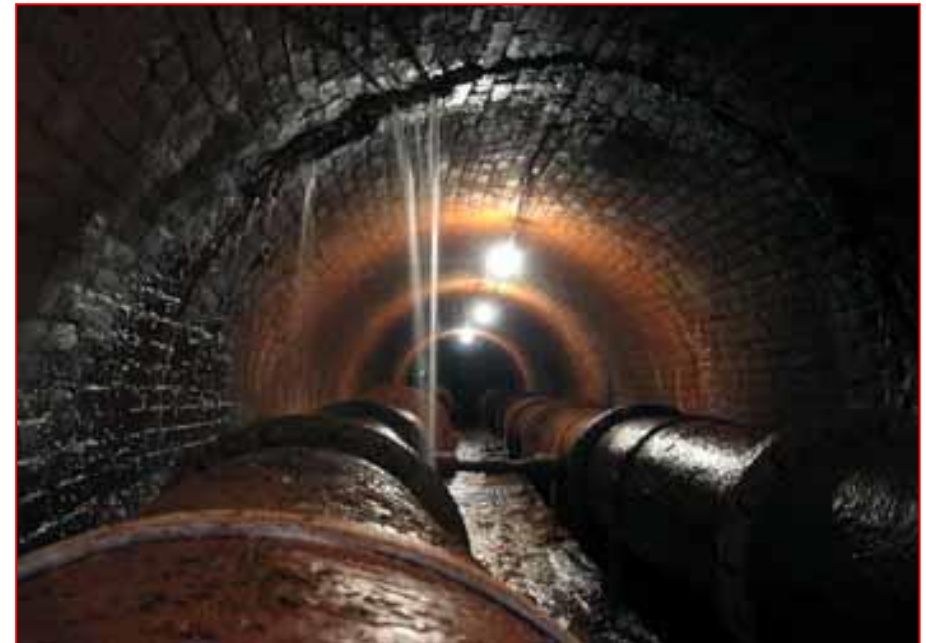
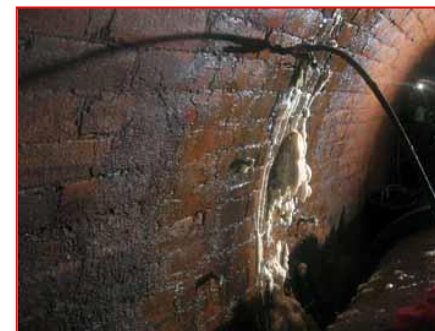
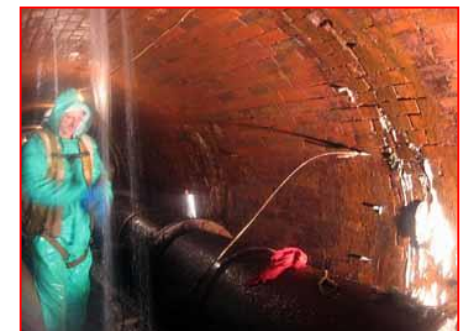
The draw off tunnel at Yeoman Hey had a long history of significant ground water ingress, complicated by accumulations of ochre sludge within the tunnel. As part of the reservoir safety programme, United Utilities commissioned Ram Services Limited to undertake an investigation to confirm the tunnel construction details, and to establish the extent to which ground water travel occurred within or behind the brick lining.

Following this investigation, which found that the lining was solidly constructed and in good condition, an approach to stemming the water ingress was developed, based on the assertion that water ingress through the tunnel lining occurred locally (and severely in places), rather than along the full extent of the lining.

In addition to the ingress through the brickwork tunnel arch lining, further occurrences of water ingress through the sandstone invert lining were stemmed using similar techniques.

On completion of the work three weeks later, the severe ingress through the brickwork and sandstone lining had been stemmed completely, although more minor ingress through the base of the tunnel walls persisted.

A variety of low viscosity polyurethane aqua reactive resin grouts were supplied for the work, which commenced at the base of the draw off tower, and then extended down the tunnel to the most severe leak around 30m downstream.
